AYN GHARANDAL

Erin Darby and Robert Darby

University of Tennessee

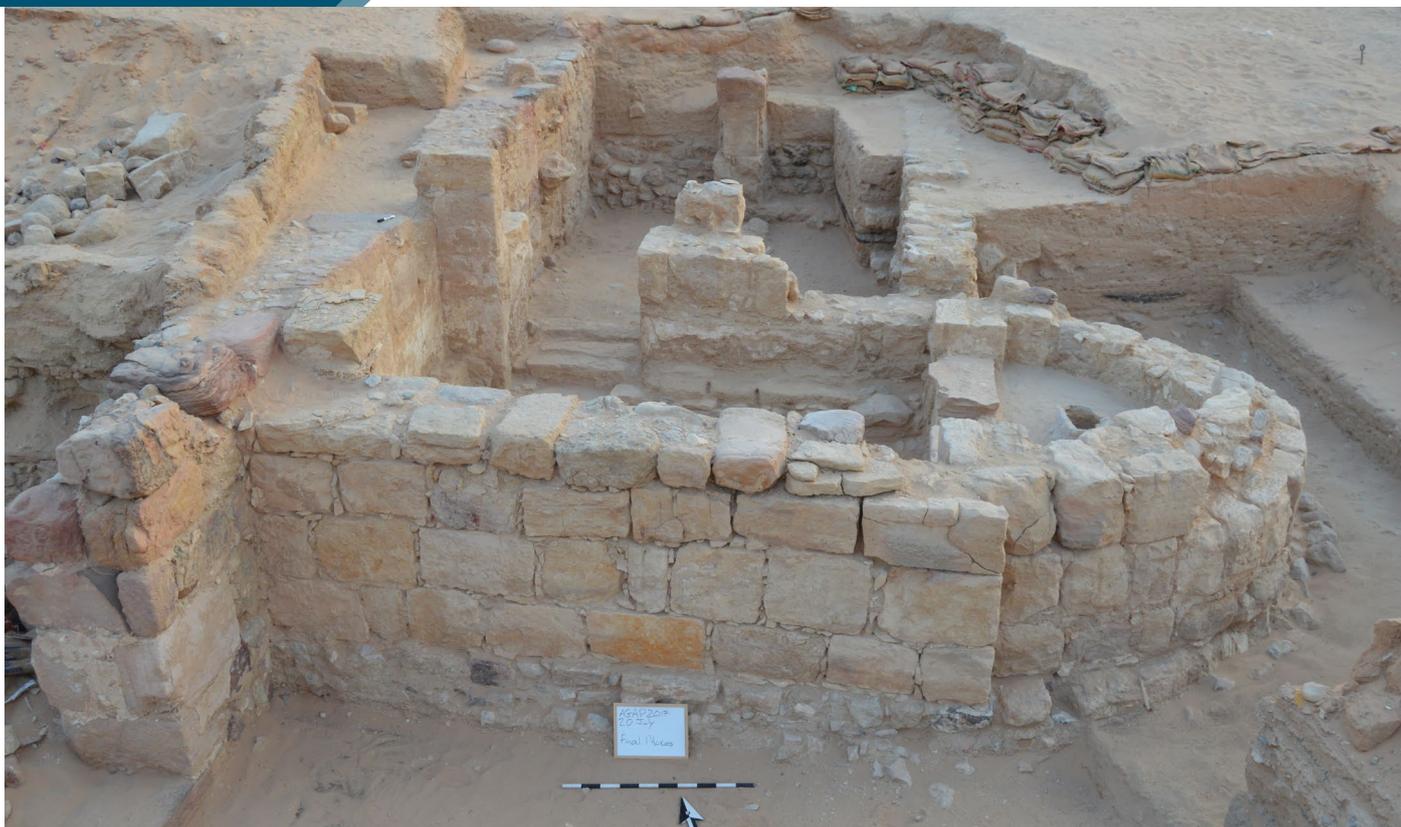
Fig. 88. The 'Ayn Gharandal church facing North

The primary objective for the 2017 season at 'Ayn Gharandal was the excavation of a small apsidal structure first discovered in 2015 and tentatively identified as an Early Christian church within the Late Roman fort. Although the 2015 excavation revealed only the southern edge of this structure, its identification as a church was based upon the discovery of a raised apse accessed by a set of stairs flanked by a large sculpted stone with a set of notches and grooves for a chancel screen. The 2017 excavation areas were chosen with the goal of fully excavating the interior of the church, exposing its exterior walls, and determining how the structure, known to be secondary to the original construction of the fort, made use of and modified the existing architecture in its design and construction. In addition to meeting these objectives, the 2017 field season also discovered and excavated an ancillary room built on the church's north side, which provided access to the church through a doorway near the northwest corner in the church's north wall via a set of stairs. The north room was, presumably, associated in some way with the function of the church (Fig. 88).

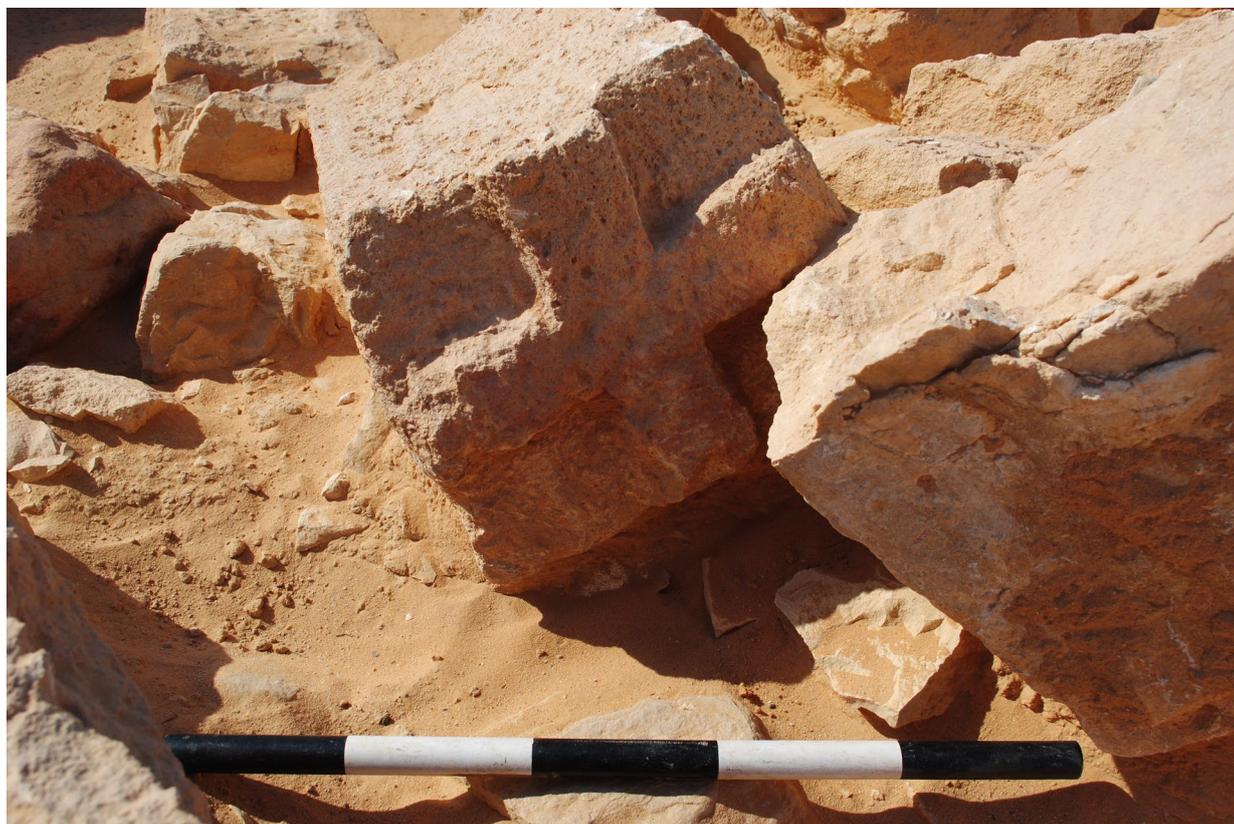
Fig. 89. Cut stone with relief of cross from the apse

Given that only two to three courses of the apse wall are preserved, most of its stones were not found *in situ*, but rather as part of a large collapse event that extended outward from the apse. The collapsed stones were of varying sizes and qualities of dressing, reflecting their position as part of both the interior and exterior apse wall rows. Discovered among the collapsed stones and still in its relative position to the apex of the apse wall was a well-dressed, oblong, stone with a cross carved in relief on one side still bearing traces of red paint (Fig. 89). Comparisons with apsidal half-dome construction elsewhere in Jordan suggests that this stone was likely situated in the center top of the apse with its decorated cross facing the nave of the church.
