JERASH NORTHWEST QUARTER PROJECT

Achim Lichtenberger

Rubina Raja

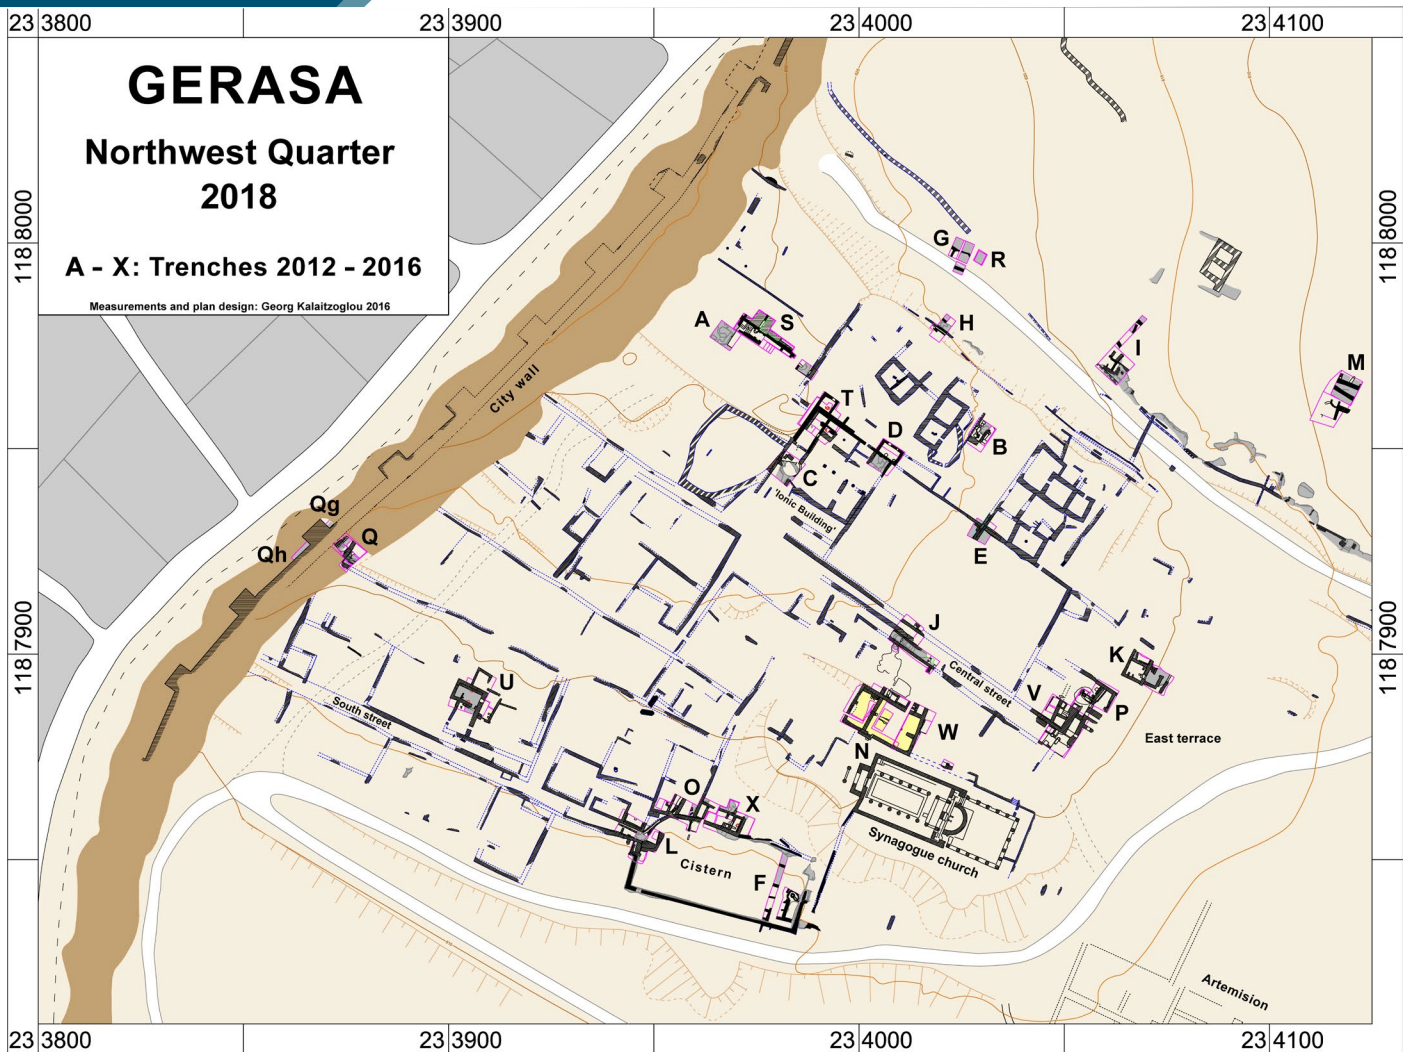
Fig. 26. Plan of the Northwest Quarter with all excavated trenches 2012–2016 marked (image courtesy of the Danish-German Jerash Northwest Quarter Project)

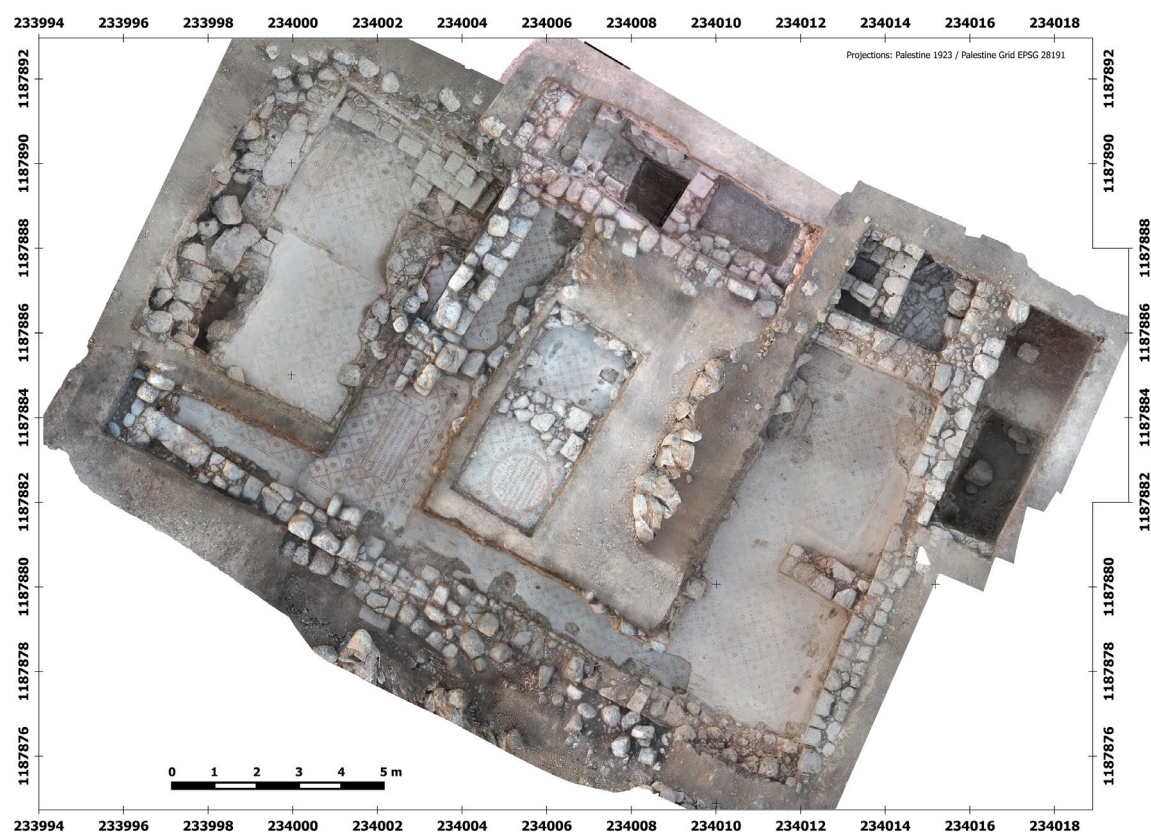
Fig. 27. Photogrammetric plan of the mosaic hall (image courtesy of the Danish-German Jerash Northwest Quarter Project)
